Re: Yeshivath Viznitz
 Special Permit Application
 235 Elm Road, Briarcliff Manor, NY

architecture team is in the process of inspecting the premises and preparing a report on the existing conditions to identify improvements needed to bring the Premises into better repair. Building Inspection Reports for West Hall, Tead House, Woodward Hall, and Valley Dorm buildings are included as **Exhibit C**. The reports for the remaining buildings will be provided upon completion. The Applicant's architect will also be providing a "Green" checklist or narrative detailing any energy efficiency upgrades being proposed.

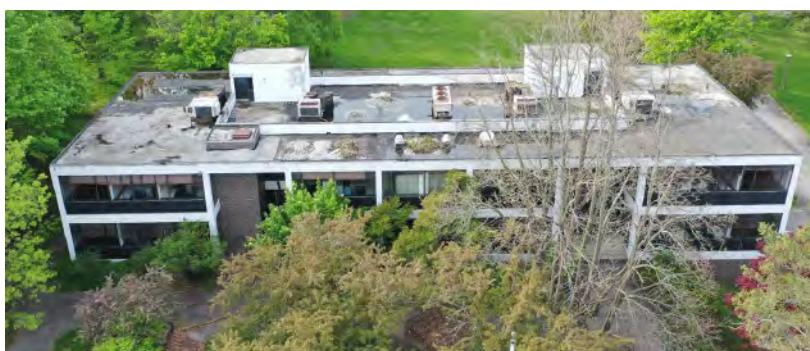
PICTURE #1

- Front elevation windows, window frames & painted curtain wall panels are in bad condition, existing windows are single pane with operable casement type mechanism.

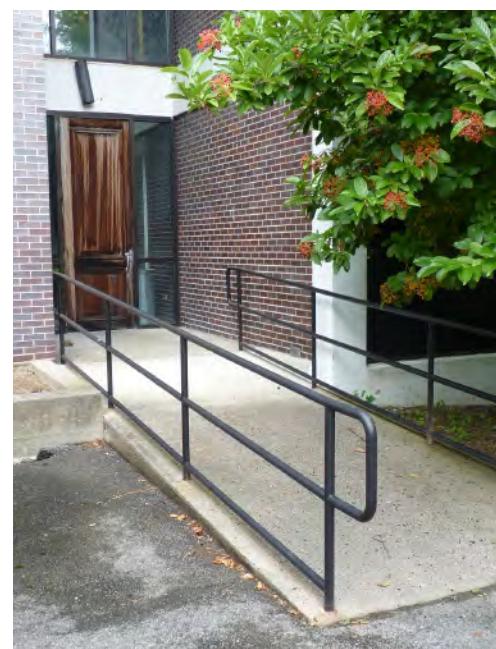
PICTURE #2

- The ADA ramp & railing at secondary entrance appears to be up to code. The wood entrance door by the ADA ramp is in bad shape and needs to be replaced with new door. (PICTURE #2)

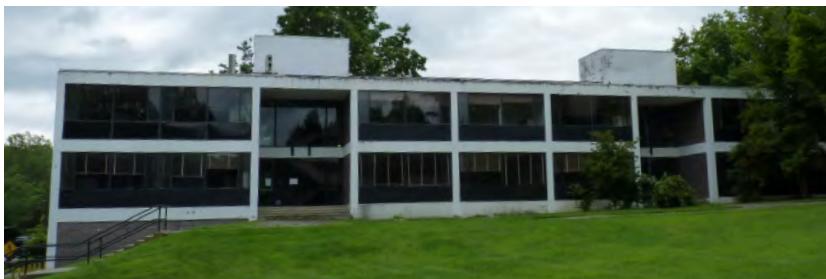
PICTURE #12

- Poured concrete structure & brick infills at front elevation are in fairly decent shape except for some hairline, zigzag & horizontal cracks. They do not appear to be major structural cracks. (PICTURE #12,#13)
- Horizontal cracks on concrete were found at the rear entrance stairs. (PICTURE #14)
- Rear elevation windows, window frames & painted curtain wall panels are in bad condition, existing windows are single pane with operable casement type mechanism. (PICTURE #13)
- Four temporary scuppers were found at rear elevation and no downspouts were connected to the scuppers. Rain from the scupper is draining directly on the facade surface and existing facade under scuppers was severely damaged. (PICTURE #15 to #18)

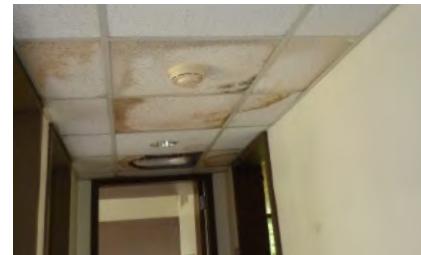
PICTURE #28

- The interior partitions are 6" CMU walls (from original construction) and light weight studs with gypsum board.
- Existing stairs railings are not up to code. Landings and treads material in many places are deteriorated and need to be resurfaced.
- Existing exit signs and emergency lights seems to be in fair condition.
- Existing elevator is out of service and needs to be checked.
- Existing bathroom facilities are still functional but needs upgrade.
- Several leakages were found at 2nd floor ceiling. Existing acoustic ceiling at leakage area was deteriorated. (PICTURE #28 & #29)

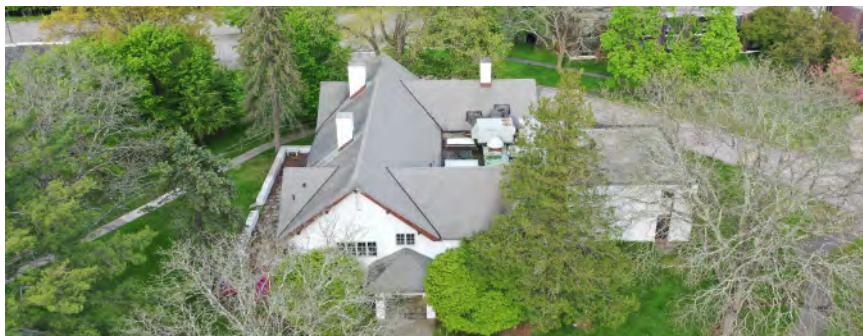
PICTURE #1

- Visible on the exterior of the building are: stucco finished concrete structure with fenestrations. (PICTURE #1)
- Existing windows are double pane windows and they are in fair condition.
- Hairline crack was observed above left side second floor windows headers. (PICTURE #2)
- Rainwater downspout on the right side of the building is broken. (PICTURE #3)
- Some vertical hairline cracks were observed on the stucco finish. (PICTURE #4)
- Some horizontal hairline cracks were observed at right side of the front elevation. (PICTURE #5 & #6)

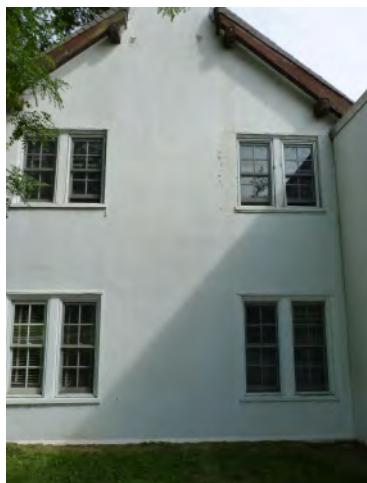
PICTURE #7

- Some vertical hairline cracks were observed on the stucco finish. (PICTURE #7)
- Some horizontal hairline cracks were observed on the stucco finish. (PICTURE #8, #9, #10, #11 & #12)

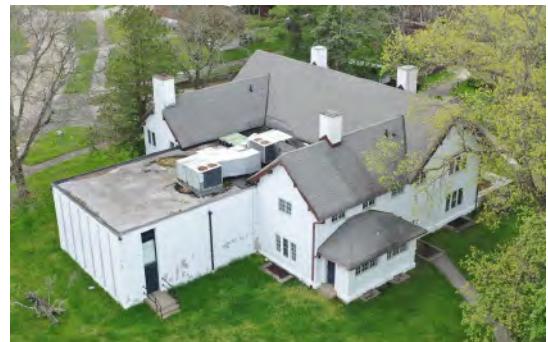
PICTURE #24

- The interior of Tead House are: carpet flooring, wood studs with gypsum board, flat gypsum board ceiling at pitched roof and dropped acoustic ceiling at flat roof.
- Existing mechanical room is located in the Basement floor level. Refer to MEP report for further information. (PICTURE #19)
- Existing railings are up to code. (PICTURE #20)
- Existing Exit signs are in fair condition.
- Existing Bathroom fixtures are in fair condition. (PICTURE #22)
- Leakage was visible on the underside of the flat roof. (PICTURE #23 & #24)

- Pitched roofs are in fair condition. (PICTURE #24)
- Flat roof is not properly draining and ponding was observed. (PICTURE #24)

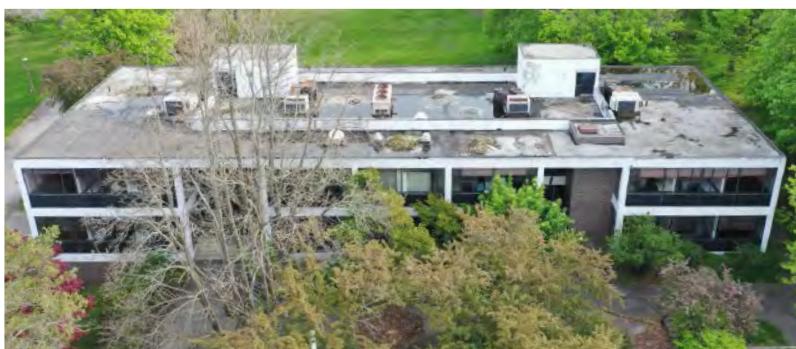
PICTURE #1

- Front elevation windows, window frames & painted curtain wall panels are in bad condition, existing windows are single pane with operable casement type mechanism. (PICTURE #1 & #3)

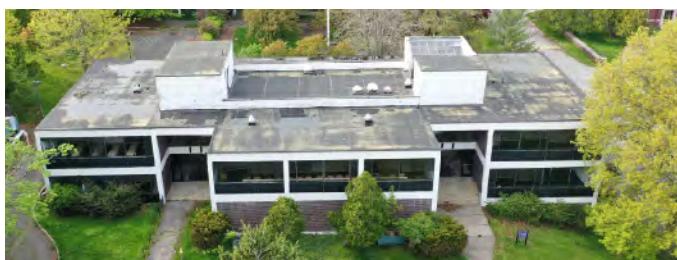
PICTURE #14

- Chipped concrete structure was observed at left side of the rear elevation. (PICTURE #15)
- Concrete landing at the rear entrances show signs of spalling, it might be in need of resurfacing. (PICTURE #16)
- All the black painted curtain wall panels are badly deteriorated and misaligned. (PICTURE #14 & #17)
- Rear entrance ceiling panels, glass and door assemblies are in fair condition. (PICTURE #16 & #17)

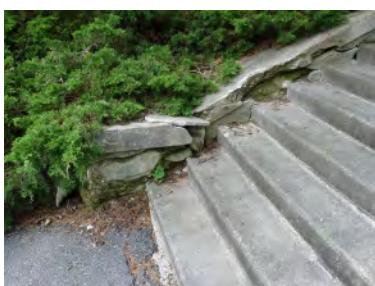
PICTURE #18

- Exterior stairs at front entrance of Woodward Hall were deteriorated. (PICTURE #18 & #19)
- Overgrown trees at the front entrance are encroaching the walkway. (PICTURE #20)

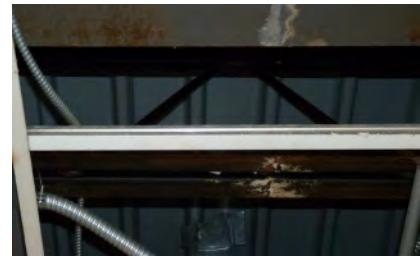
PICTURE #27

- The interior partitions are 6" CMU walls (from original construction) and light weight studs with gypsum board.
- Existing stairs railings are not up to code. Landings and treads material in many places are deteriorated and needs to be resurfaced.
- Existing exit signs and emergency lights were in fair condition.
- Existing elevator is out of service and needs to be checked.
- Existing bathroom facilities are still functional but needs upgrade.
- Existing roof structure is steel beams with underlaid metal deck with open web steel joists. (PICTURE #27 & #28)

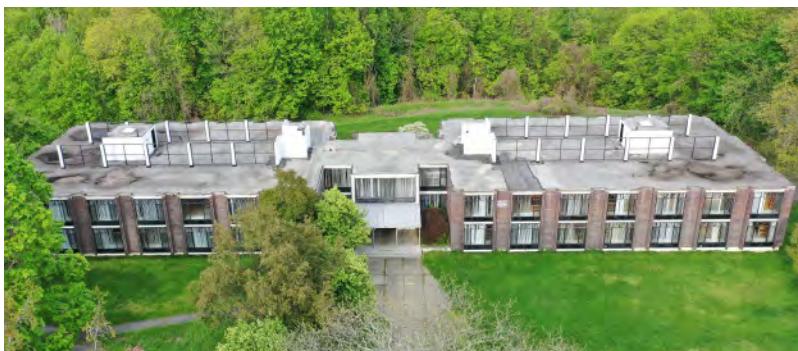
PICTURE #1

- Visible on the exterior of the building are: the poured concrete structure, brick infills with black painted curtain wall panels & fenestrations. (PICTURE #1 & #2)
- Poured concrete structure & brick infills at front elevation are in fairly decent shape except for some cracks & chipped bricks. (PICTURE #4 & #5)
- Front elevation window frames & painted curtain wall panels are in bad condition, existing windows are single pane casement windows with central fixed window. (PICTURE #2)
- Weep holes in the brick facade seems clogged at the indicated location. (PICTURE #3)
- Chipped brick was observed on the right side of the elevation. (PICTURE #5)

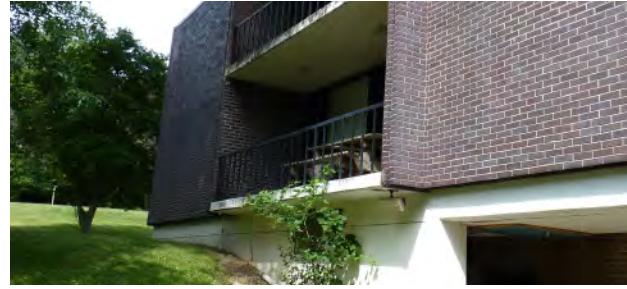
PICTURE #7

- Loose bricks/displaced bricks were observed at right elevation where concrete slab meets the vertical brick wall near first level railing. (PICTURE #6)
- Railing on the first and second level covered balcony are not up to code. Railings needs to be painted properly and maintained. (PICTURE #7)
- Concrete slabs of balconies needs to be power washed. (PICTURE #7 & #8)

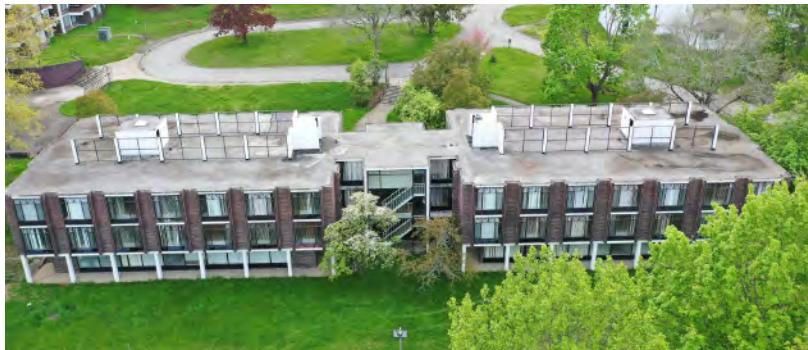
PICTURE #21

- Roof seems to be in fairly decent condition and no obvious leakage was found at the 2nd floor ceiling. (PICTURE #21)
- Existing EPDM membrane patch up was observed at shown location and appears to be in good condition. (PICTURE #22)
- EPDM membrane was worn at some locations. (PICTURE #23)
- Existing reglets on masonry walls were in bad condition. (PICTURE #24)
