Foundation Design, P.C.

Reference: Briarcliff Solar Facility/Ridgewood Solar Facility
345 Scarborough Rd, Briarcliff Manor, New York
Geotechnical Evaluation, 5184.0

This report summarizes our geotechnical evaluation for the referenced project. We understand you intend to construct two, 5.0 mW solar array systems to be located west of Scarborough Road in Briarcliff Manor, New York. We base this evaluation on our review of U.S.G.S. topographic and geologic mapping; NYS geologic mapping; NRSC Soils mapping; FEMA flood plain mapping; new soil boring exploration; field and lab testing; and consultation with the design team. YSG Community Solar retained Foundation Design, P.C. to perform the services outlined in our March 29, 2022 *Geotechnical Services Proposal, P5032.0*. We intend this report for use exclusively on this project.

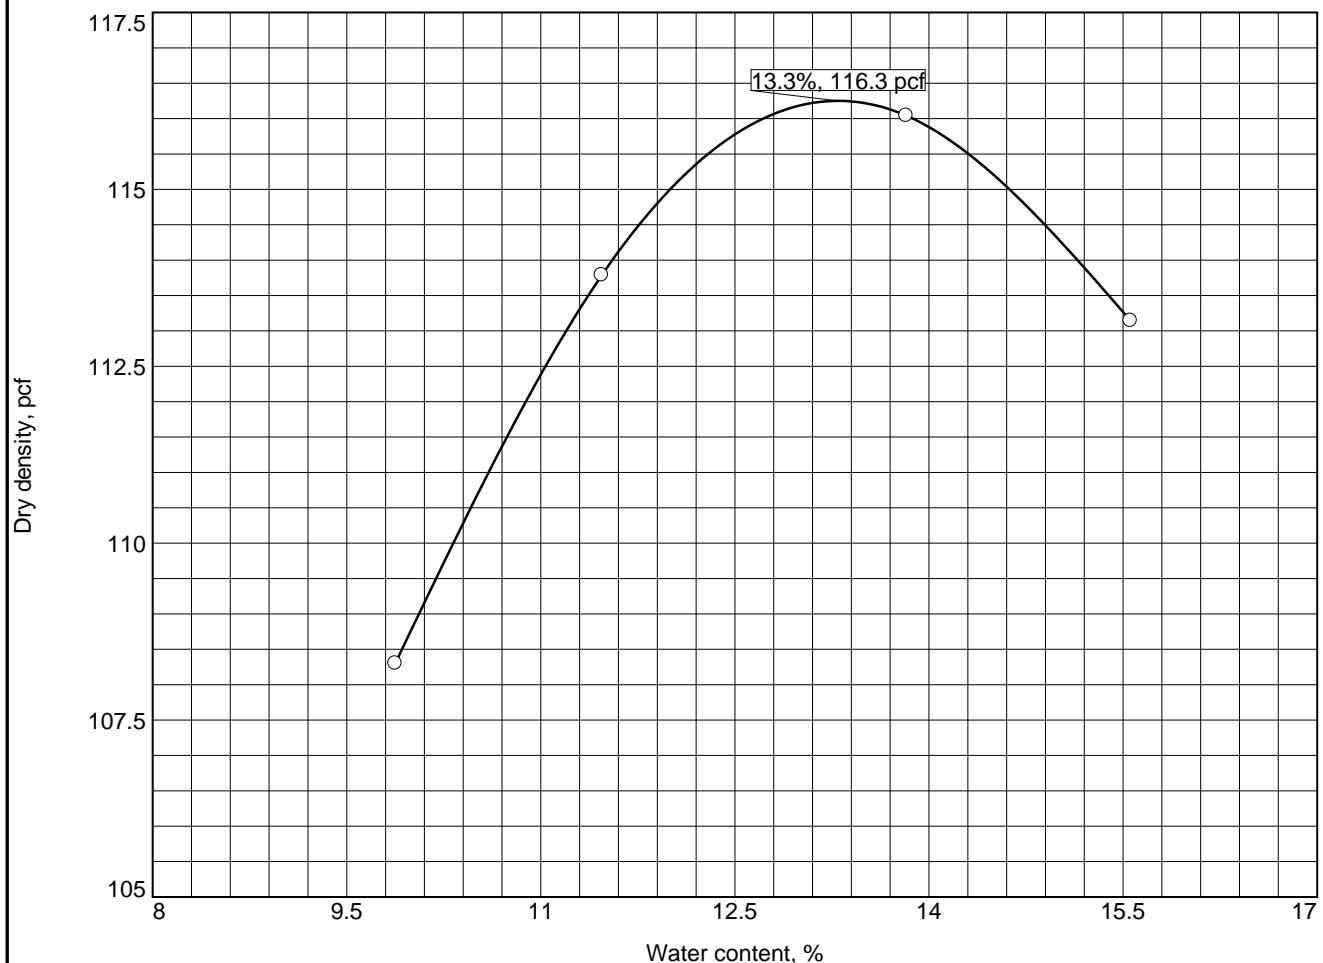
COMPACTION TEST REPORT

Test specification: ASTM D 698-07 Method B Standard

Elev/ Depth	Classification		Nat. Moist.	Sp.G.	LL	PI	% > 3/8 in.	% < No.200		
	USCS	AASHTO								
			16.0				3.3			
TEST RESULTS						MATERIAL DESCRIPTION				
Maximum dry density = 116.3 pcf						ID#22-398				
Optimum moisture = 13.3 %										
Project No. 22-011 Project:	Client: Foundation Design						Remarks:			
<input checked="" type="checkbox"/> Source of Sample: Briarcliff Solar	Sample Number: Briarcliff Solar									
3rd Rock, LLC										
East Aurora, NY						Figure

We recovered a bulk sample of material at B22-12 for the soil thermal conductivity testing. The Standard Proctor test indicates that the bulk sample has a maximum dry density of 116.3pcf that occurs at a moisture content of 13.3 percent. We asked the lab to condition the bulk sample to 95 percent of the maximum dry density (110.5pcf) for the soil thermal conductivity testing. The soil thermal conductivity values (Rho) documented as the material dried out are shown in Table No. 2 below.
