Re: Yeshivath Viznitz
 Special Permit Application
 235 Elm Road, Briarcliff Manor, NY

architecture team is in the process of inspecting the premises and preparing a report on the existing conditions to identify improvements needed to bring the Premises into better repair. Building Inspection Reports for West Hall, Tead House, Woodward Hall, and Valley Dorm buildings are included as **Exhibit C**. The reports for the remaining buildings will be provided upon completion. The Applicant's architect will also be providing a "Green" checklist or narrative detailing any energy efficiency upgrades being proposed.

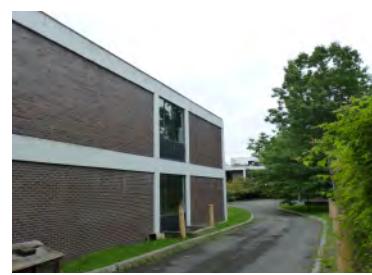
PICTURE #10

- Left elevation was in fair condition except for some hairline cracks. (PICTURE #10)
- Mechanical shaft metal grid was damaged, the poured concrete walls at mechanical shaft were in fair condition. (PICTURE #11)

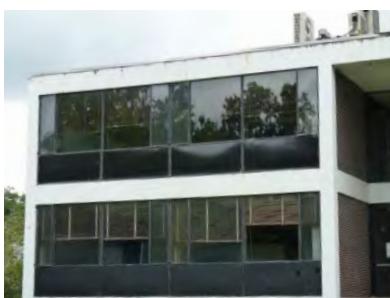
PICTURE #13

- Poured concrete structure & brick infills at front elevation are in fairly decent shape except for some hairline, zigzag & horizontal cracks. They do not appear to be major structural cracks. (PICTURE #12,#13)
- Horizontal cracks on concrete were found at the rear entrance stairs. (PICTURE #14)
- Rear elevation windows, window frames & painted curtain wall panels are in bad condition, existing windows are single pane with operable casement type mechanism. (PICTURE #13)
- Four temporary scuppers were found at rear elevation and no downspouts were connected to the scuppers. Rain from the scupper is draining directly on the facade surface and existing facade under scuppers was severely damaged. (PICTURE #15 to #18)

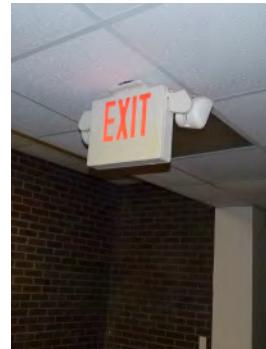
PICTURE #21

- Ground floor interior partitions are 6" brick/CMU walls and light weight studs with gypsum board. (PICTURE #20, #21)
- Existing mechanical room is located 4' below ground floor level. Mechanical equipments did not look up to code but refer to MEP report for more details. (PICTURE #19)
- Most of the exit signs and emergency lights were in fair condition, few need to be replaced. (PICTURE #20, #21)
- Existing bathroom facilities are still functional but needs upgrade.

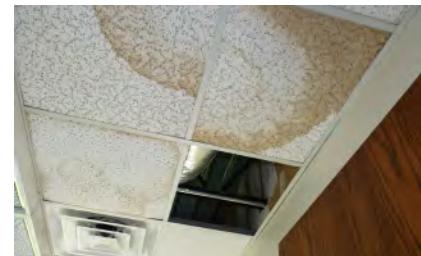
PICTURE #29

- The interior partitions are 6" CMU walls (from original construction) and light weight studs with gypsum board.
- Existing stairs railings are not up to code. Landings and treads material in many places are deteriorated and need to be resurfaced.
- Existing exit signs and emergency lights seems to be in fair condition.
- Existing elevator is out of service and needs to be checked.
- Existing bathroom facilities are still functional but needs upgrade.
- Several leakages were found at 2nd floor ceiling. Existing acoustic ceiling at leakage area was deteriorated. (PICTURE #28 & #29)

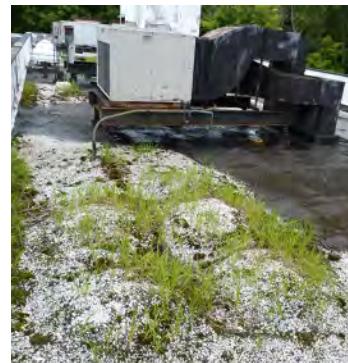
PICTURE #29

- Entire roof is severely compromised. The existing roofing EPDM membrane is in bad condition and it needs to be replaced. The roof is not draining properly and there is considerable vegetation growth over the roof. (PICTURE #29 to #33)
- Entire roof is not properly pitched and pounding is observed literally everywhere. (PICTURE #29 to #32)
- Scuppers were not connected to the downspouts and rain is draining directly on the building facade surface. (PICTURE #31)
- Existing HVAC equipments dunnage is not transferring load to perimeter walls but rather relying on pitch pocket in the middle of the roof. (PICTURE #29)
- Both bulkhead roofs are compromised, existing bulkhead ceilings are deteriorated. (PICTURE #29)

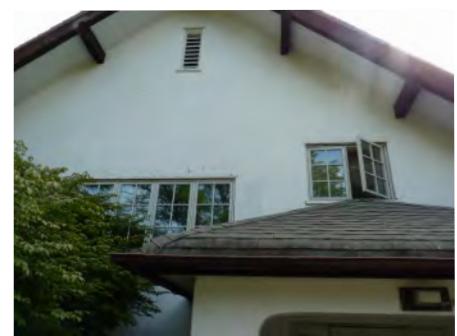
PICTURE #2

- Visible on the exterior of the building are: stucco finished concrete structure with fenestrations. (PICTURE #1)
- Existing windows are double pane windows and they are in fair condition.
- Hairline crack was observed above left side second floor windows headers. (PICTURE #2)
- Rainwater downspout on the right side of the building is broken. (PICTURE #3)
- Some vertical hairline cracks were observed on the stucco finish. (PICTURE #4)
- Some horizontal hairline cracks were observed at right side of the front elevation. (PICTURE #5 & #6)

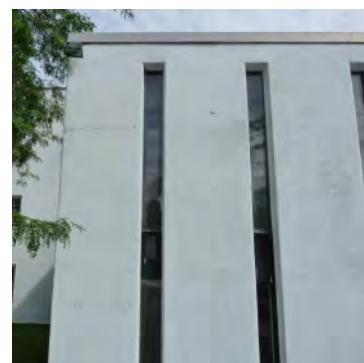
PICTURE #9

- Some vertical hairline cracks were observed on the stucco finish. (PICTURE #7)
- Some horizontal hairline cracks were observed on the stucco finish. (PICTURE #8, #9, #10, #11 & #12)

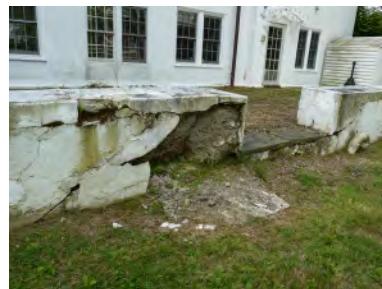
PICTURE #15

- Some hairline cracks were observed on the stucco finish. (PICTURE #13 & #14)
- CMU boundary wall was cracked and damaged. (PICTURE #15 & #16)

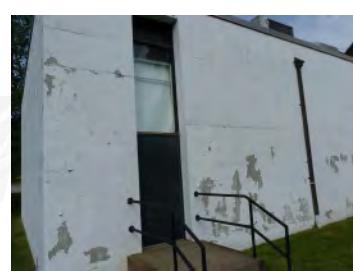
PICTURE #17

- Some hairline horizontal cracks were observed on left side of the rear elevation. (PICTURE #17)
- Window lintel caulking seems deteriorated on right side of the rear elevation.(PICTURE #18)

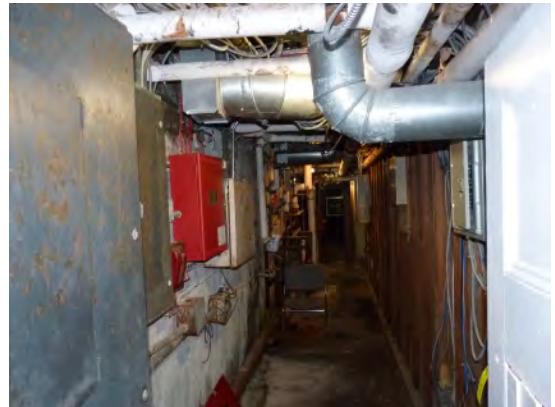
PICTURE #19

- The interior of Tead House are: carpet flooring, wood studs with gypsum board, flat gypsum board ceiling at pitched roof and dropped acoustic ceiling at flat roof.
- Existing mechanical room is located in the Basement floor level. Refer to MEP report for further information. (PICTURE #19)
- Existing railings are up to code. (PICTURE #20)
- Existing Exit signs are in fair condition.
- Existing Bathroom fixtures are in fair condition. (PICTURE #22)
- Leakage was visible on the underside of the flat roof. (PICTURE #23 & #24)

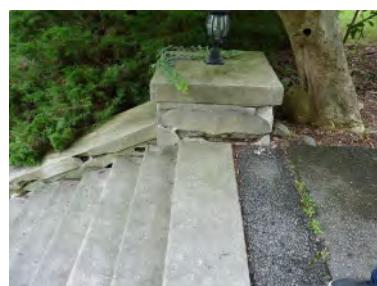
PICTURE #19

- Exterior stairs at front entrance of Woodward Hall were deteriorated. (PICTURE #18 & #19)
- Overgrown trees at the front entrance are encroaching the walkway. (PICTURE #20)

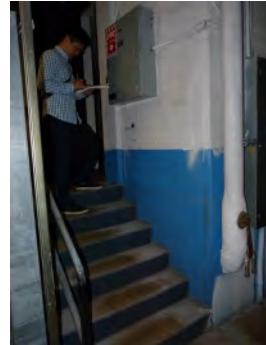
PICTURE #21

- Ground floor interior partitions are 6" CMU walls and light weight studs with gypsum board.
- Existing mechanical room is 42" below the ground floor level. The existing mechanical equipments did not look up to date but refer to MEP report for further details. (PICTURE #21)
- Existing exit signs and emergency lights were in fair condition.
- Existing bathroom facilities are still functional but needs upgrade.

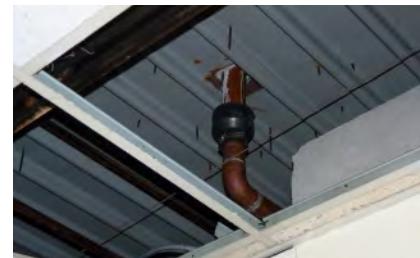
PICTURE #28

- The interior partitions are 6" CMU walls (from original construction) and light weight studs with gypsum board.
- Existing stairs railings are not up to code. Landings and treads material in many places are deteriorated and needs to be resurfaced.
- Existing exit signs and emergency lights were in fair condition.
- Existing elevator is out of service and needs to be checked.
- Existing bathroom facilities are still functional but needs upgrade.
- Existing roof structure is steel beams with underlaid metal deck with open web steel joists. (PICTURE #27 & #28)

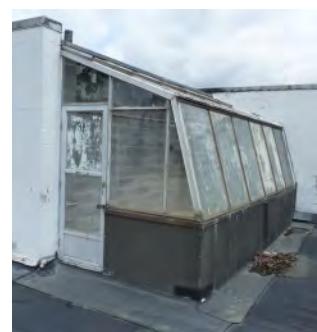
PICTURE #29

- Entire roof is compromised. The existing roofing EPDM membrane is in bad condition and it needs to be replaced. (PICTURE #30-34)
- Entire roof is not properly pitched and there is considerable pounding on both side of the center parapet and the roof is not draining properly. (PICTURE #31-34)
- There is an existing rooftop green house. Probably for science lab. (PICTURE #29)

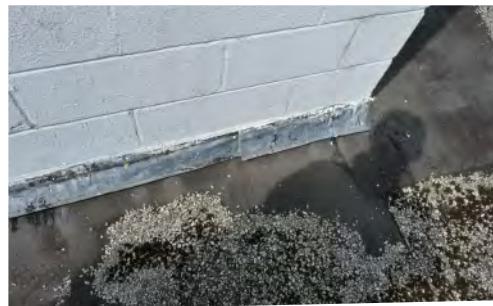
PICTURE #24

- Roof seems to be in fairly decent condition and no obvious leakage was found at the 2nd floor ceiling. (PICTURE #21)
- Existing EPDM membrane patch up was observed at shown location and appears to be in good condition. (PICTURE #22)
- EPDM membrane was worn at some locations. (PICTURE #23)
- Existing reglets on masonry walls were in bad condition. (PICTURE #24)
